PART IV-EXISTING SYSTEM PERFORMANCE

This section presents the results of the hydrologic and hydraulic analysis of Manhattan's major drainage system using the HEC-1, HEC-2 and URBMOD computer models as described in Part III of this report. The analysis was based on the storm drainage system and land use as they existed in the fall of 1993. The performance of the existing system was reviewed based on both the current municipal drainage design criteria and the proposed "Stormwater Management Criteria" document, a copy of which is included as Appendix I to this report.

CITY OF
MANHATTAN KANSAS
 STORMWATER MANAGEMENT
 PLAN
 FIGURE IV - 1
 WATERSHED KEY MAP

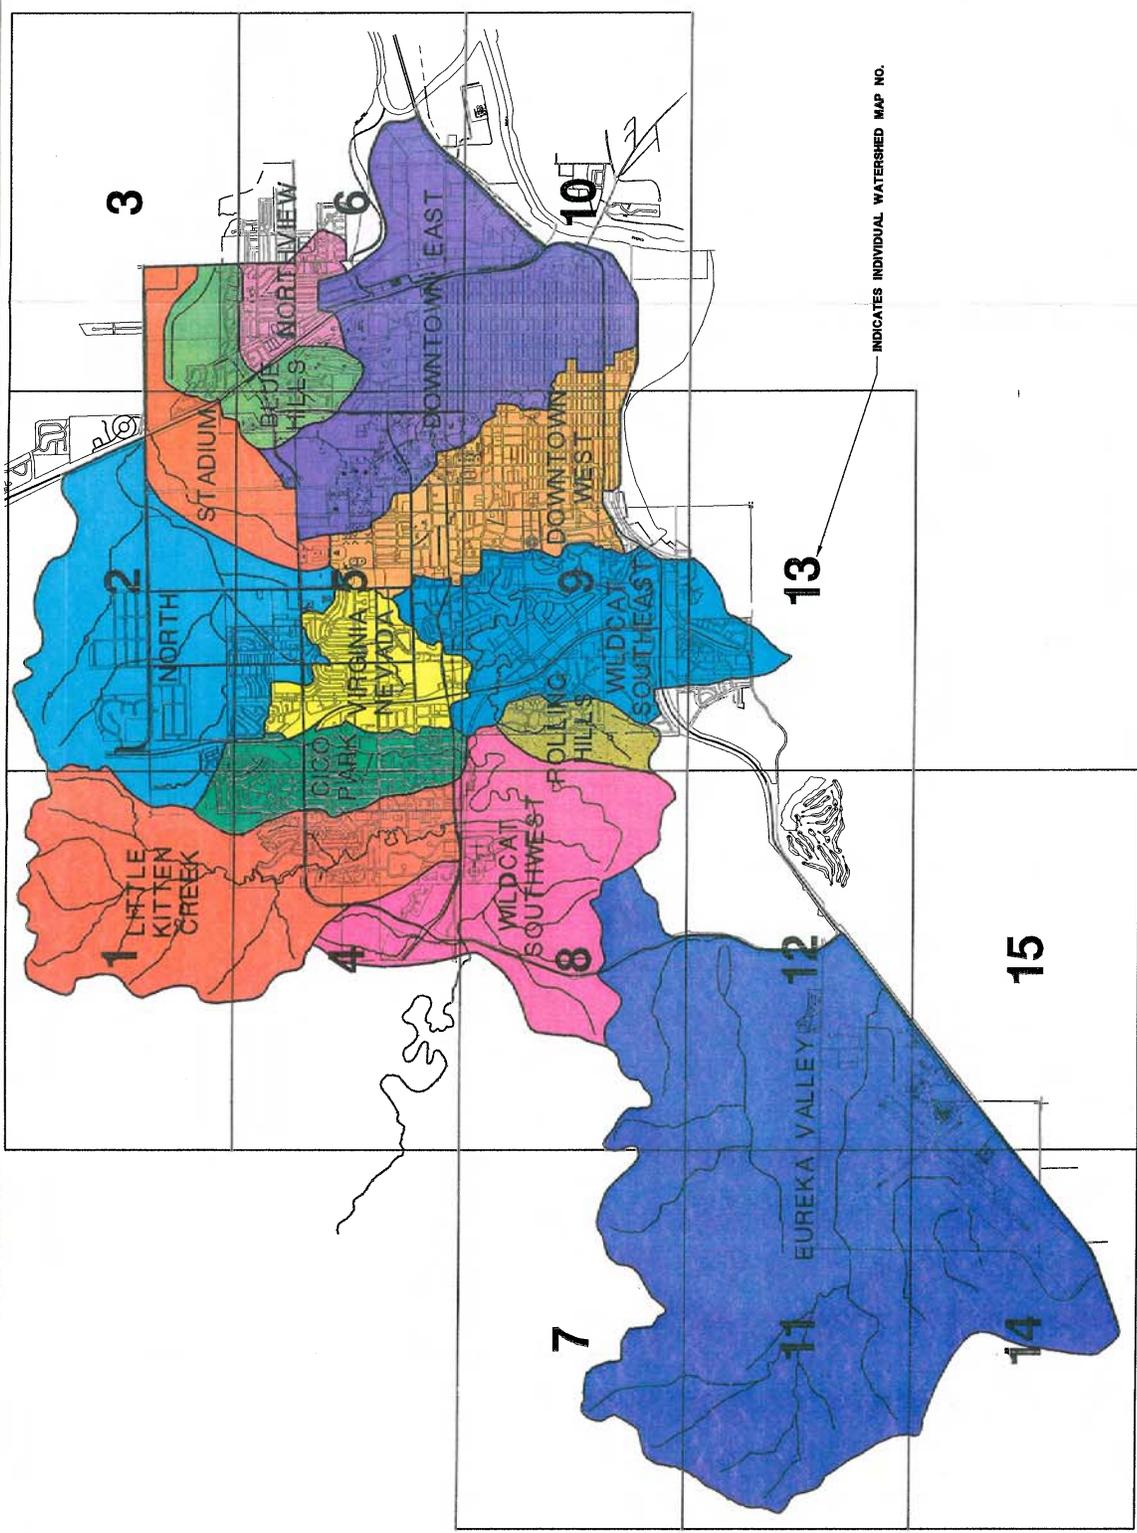
Basin area incorporated into the models totals 28.3 square miles, or 18,115 acres. System maps indicating watershed limits and individual model reaches are included at the end of this section for reference. Larger scale maps with additional information for use in reviewing and using the more specific technical data developed as part of this study have been separately furnished to city staff members. A summary description of the model content is indicated by Table IV-1.

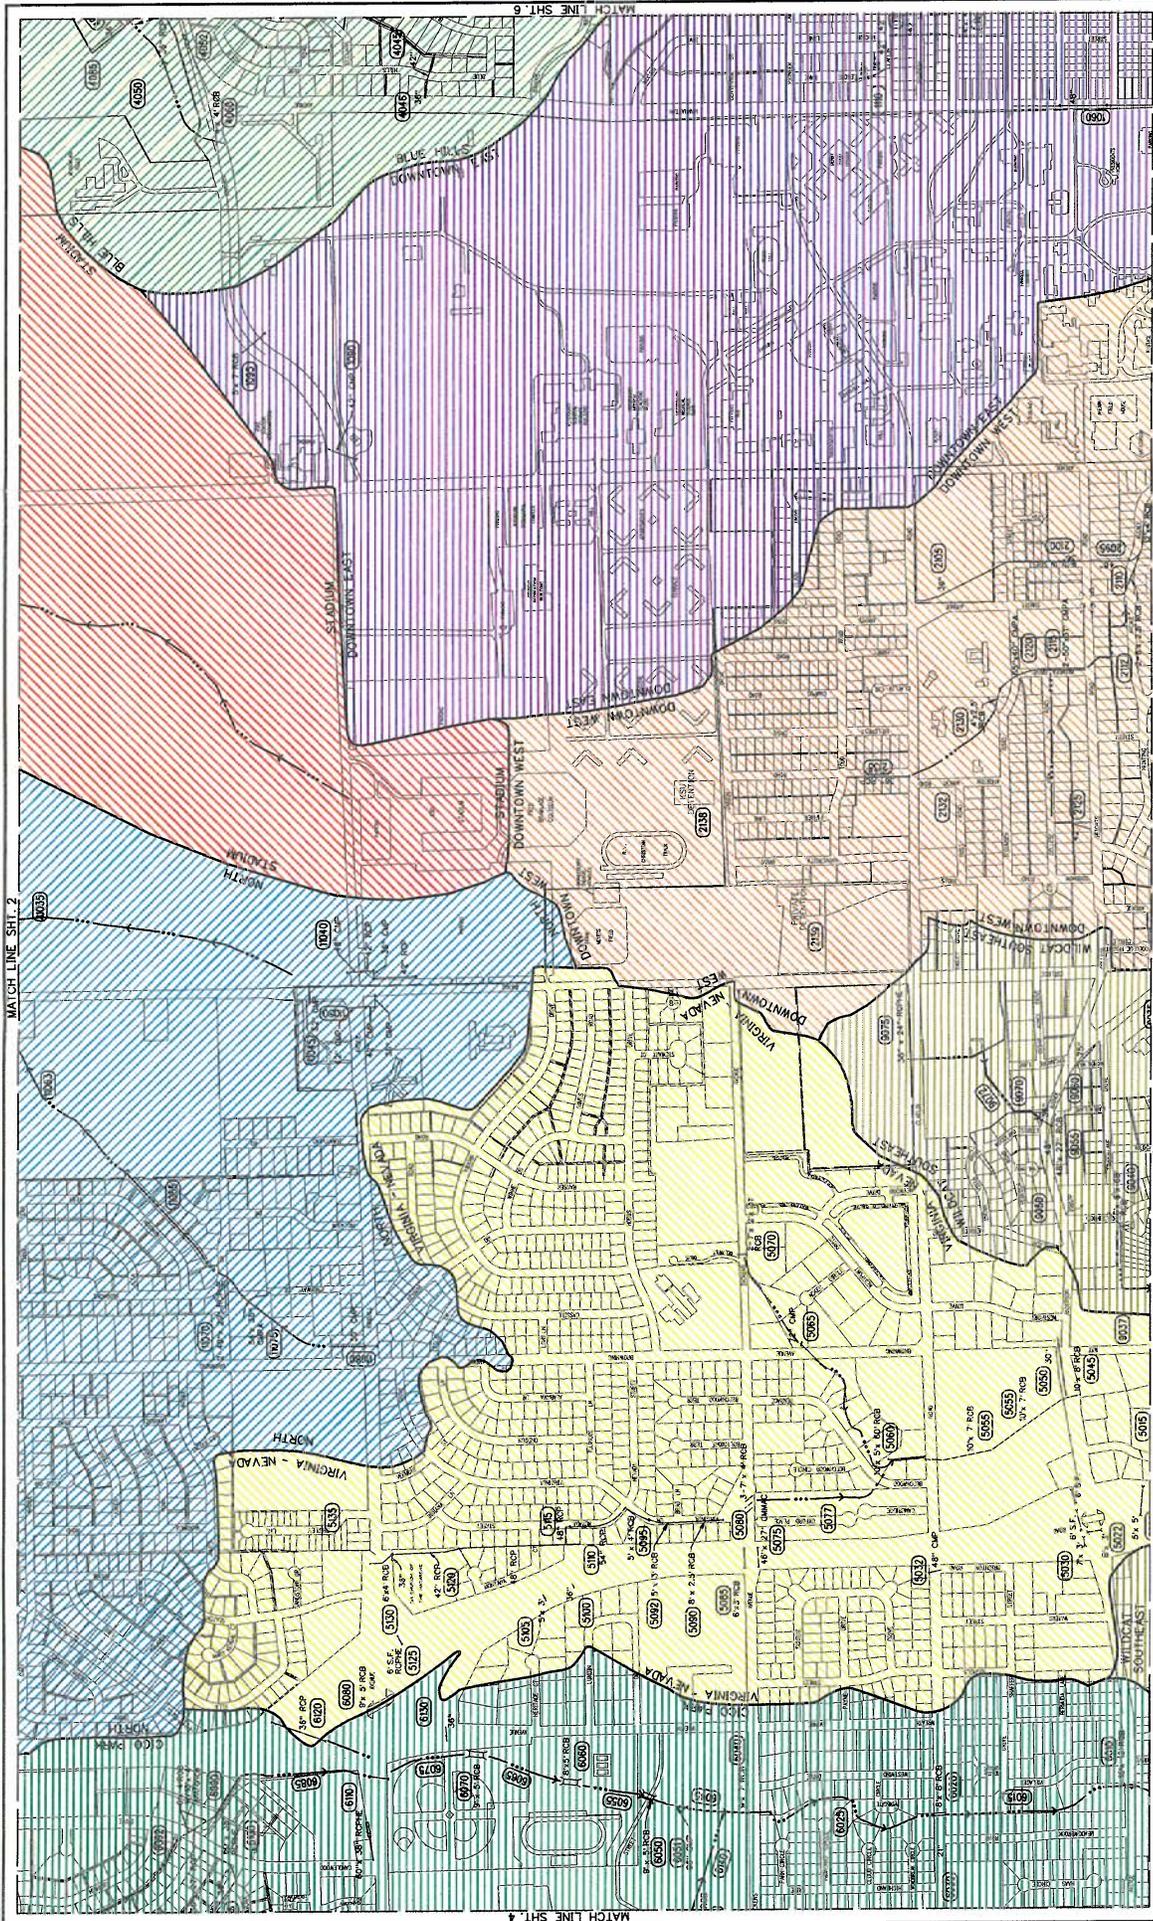
**CITY OF
MANHATTAN KANSAS**
STORMWATER MANAGEMENT
PLAN
FIGURE IV - 6
WATERSHED MAP NO. 5

1081	5/6	2-5'x 4' RCB along Bertrand - 7th to Manhattan
1085	5	Natural channel through KSU campus
1090	5	42" CMP across Kimball
1092	5	Roadside ditch, north side of Kimball
1095	5	5'x 7' RCB across Kimball
1100	5	4'x 4' RCB along N. 12th Street to Ratone
1105	5	42" CMP between Claflin & Ratone
1110	5	36" CMP along Legore Lane
1112	6	72" CMP through levee southeast of Casement & Hayes
1113	6	72" CMP across Hayes Dr., south of Casement
1114	6	Channel from diversion struc., north to Hayes Dr.
1115	6	54" RCP across Tuttle Creek Blvd.
1120	6	48" RCP along Holiday Drive
1125	6	4'x 4' RCB across Tuttle Creek Boulevard
1127	6	Roadside ditch, east side of Tuttle Creek Blvd.
1130	6	84" CMP across Casement Road
1135	6	30" RCP across Casement Road

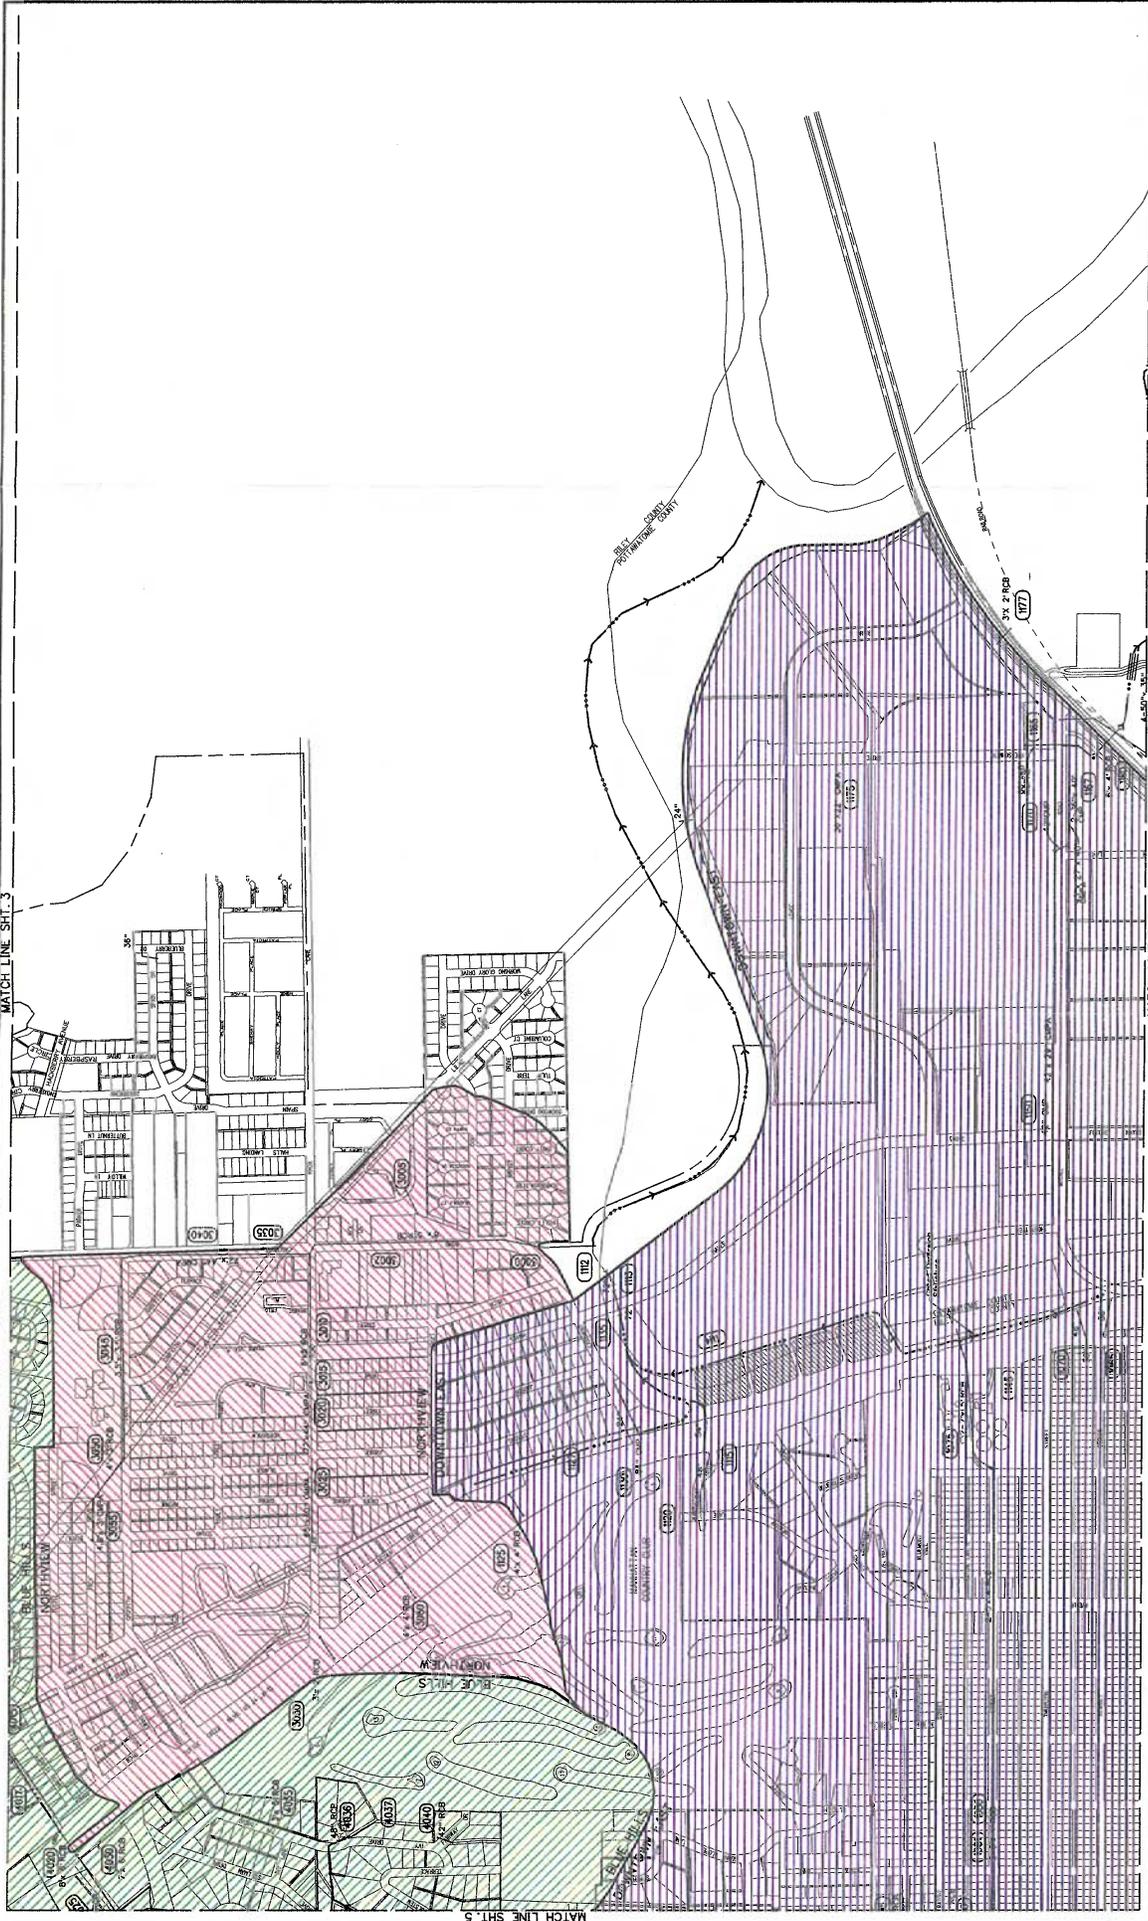
**CITY OF
MANHATTAN KANSAS**
STORMWATER MANAGEMENT
PLAN
FIGURE IV - 7
WATERSHED MAP NO. 6

<u>REACH NO.</u>	<u>MAP NO. REFERENCE</u>	<u>DESCRIPTION</u>
1000	10	72" CMP through levee near K-177 Bridge
1005	10	54" RCP across Ft. Riley Blvd.
1010	10	48" RCP along Pierre, south side of Town Center Mall
1015	10	36" RCP along 3rd Street west side of mall
1020	10	10' x 10' RCB to pump station
1025	10	12' x 10' RCB across US24
1030	10	36"/54" RCP across Tuttle Creek Blvd.
1031	10	2-48" RCPs across Tuttle Creek Blvd.
1035	10	66" RCP across mall parking & along Leavenworth St.
1039	10	60" RCP on 3rd St., west side of mall
1040	10	2-36" RCPs at 3rd & Poyntz
1045	10	42" RCP across Tuttle Creek Blvd.
1050	10	66" RCP along Bluemont Avenue
1055	9/10	54" RCP along Bluemont Avenue
1060	5/9	48" RCP along Manhattan Avenue
1062	10	36" CMP across Tuttle Creek Boulevard
1065	6	36" pipe along 3rd Street
1070	6	48" pipe across Tuttle Creek Boulevard
1075	6	2-7'x 5' RCB across water plant & Tuttle Creek Blvd.
1080	6	2-5'x 4' RCB along Bertrand - 5th to 7th

<u>REACH NO.</u>	<u>MAP NO. REFERENCE</u>	<u>DESCRIPTION</u>
3000	6	8'x 5' RCB along Casement - South of Dix
3002	6	8'x 5' RCB along Casement - Allen to Dix
3005	6	48" RCP, along north end of Gladiola Ct.
3010	6	6'x 5' RCB along Allen Road
3015	6	6'x 5' RCB along Allen Road.

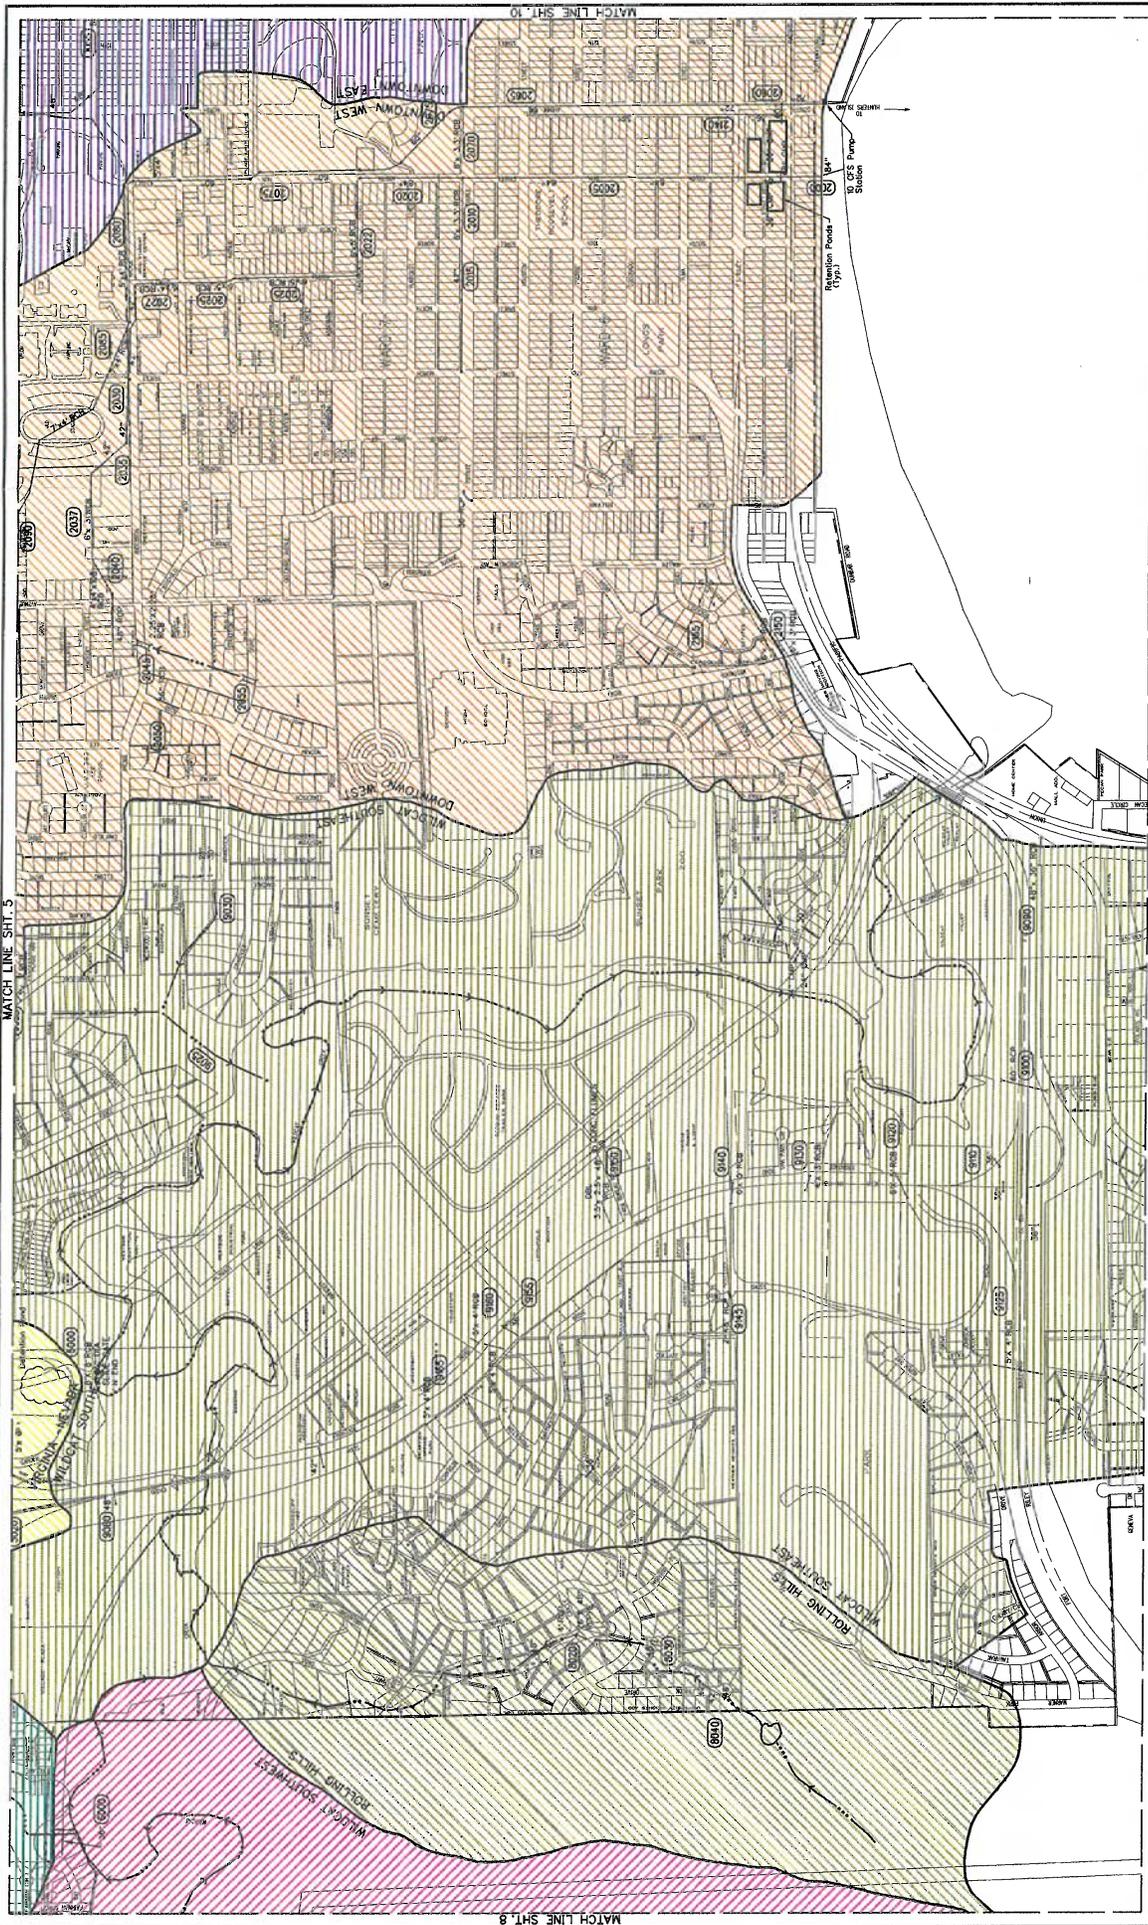
CITY OF
MANHATTAN KANSAS
 STORMWATER MANAGEMENT
 PLAN
 FIGURE IV - 10
 WATERSHED MAP NO. 9

<u>REACH NO.</u>	<u>MAP NO. REFERENCE</u>	<u>DESCRIPTION</u>
2000	9	84" RCP along 14th, south of UPRR
2005	9	84" RCP along 14th - Poyntz to UPRR
2010	9	6'x 3.3' RCB along Poyntz
2015	9	42" RCP along Poyntz
2020	9	84" RCP along 14th - Leavenworth to Poyntz
2022	9	6'x 5' RCB along Leavenworth
2025	9	6'x 5' RCB along 16th
2027	9	6'x 4' RCB along 16th
2030	9	42" RCP along Anderson
2035	9	42" RCP across Denison
2037	9	6'x 3' RCB, west of Denison
2040	9	4'x 4' RCB across Sunset (with 48" RCP inlet)
2045	9	2.25'x 2.25' RCB across Anderson
2050	9	36" RCP across Wickam
2052	9	Channel from Grandview Dr. to Anderson
2055	9	1.5'x 2.5'/1.75'x 3.25' RCB across Grandview Dr.
2060	9	72" RCP along Manhattan - Levee to Pierre

REACH NO.	MAP NO. REFERENCE	DESCRIPTION
2065	9	66" RCP along Manhattan - Poyntz to Pierre
2070	9	6'x 3.3' RCB along Poyntz
2075	9	60" RCP along 14th & through city park
2079/2080	9	5'x 4' RCB along Anderson
2085	5	7'x 4' RCB through campus
2090	5	12 x 4' RCB along Hunting
2095	5	48" RCP along McCollum
2100	5	36" RCP along McCollum
2105	5	36" RCP - Tecumseh to Claflin
2110	5	2-6'x 2.5' RCB along Hunting
2112	5	Backyard channel - College Hts. to Hunting
2115	5	2-50"x 31" CMPA along Quivera
2120	5	65"x 44" CMPA across Tecumseh
2122	5	College View (street as channel)
2125	5	42" RCP - College Hts to College View
2130	5	4'x 2.5' RCB along Tecumseh near Memorial Hospital
2132	5	Unimproved channel - Claflin to Tecumseh
2135	5	36" RCP across Claflin
2138	5	KSU detention pond, north of Jardine & Hartford
2139	5	Private detention pond, west of University & Todd
2140	9	36" RCP along Manhattan
2145	9	24" RCP through levee at 10th St.
