**PHASE I ENVIRONMENTAL SITE
ASSESSMENT REPORT**

**PROPOSED
MANHATTAN BUSINESS PARK
MANHATTAN, KANSAS**

December 16, 1996

DPRA Project Number 3850.000

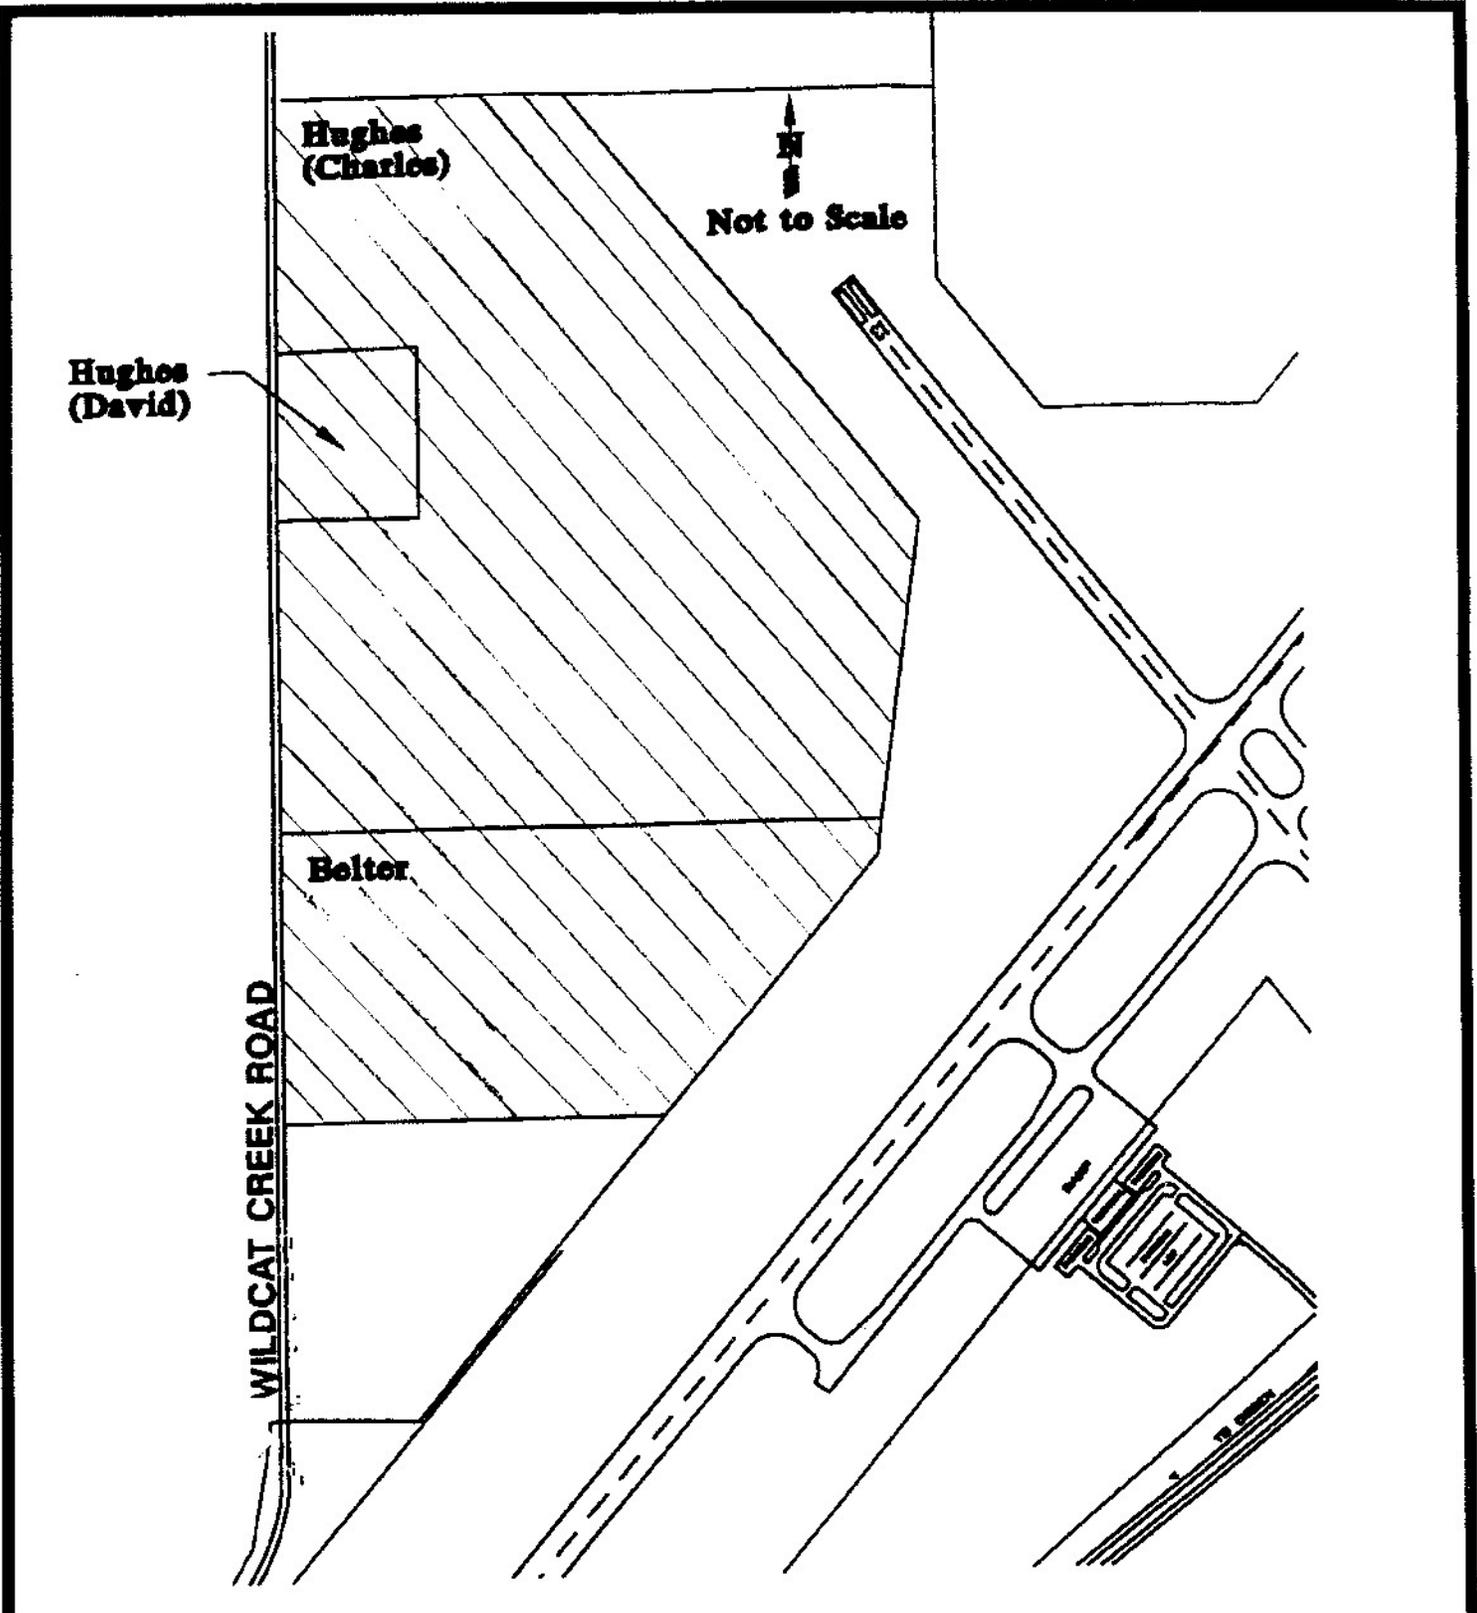
FIGURE 2
OWNERSHIP MAP

The Charles Hughes property, totaling approximately 116 acres, is comprised of parcel 11 (located in the south half of the southwest quarter section of Section 29, Township 10, Range 7 East) and parcel 2 (located in the north half of the northwest quarter section of Section 32, Township 10, Range 7 East). The David Hughes property is the residence at 4626 Wildcat Creek Road and is situated on a 10 acre tract in parcels 11 and 2. Lastly, the Margaret Belter property is located in parcel 3 which is in the south half of the northwest quarter section of Section 32, Township 10, Range 7 East (65.33 acres). See Figure 2.

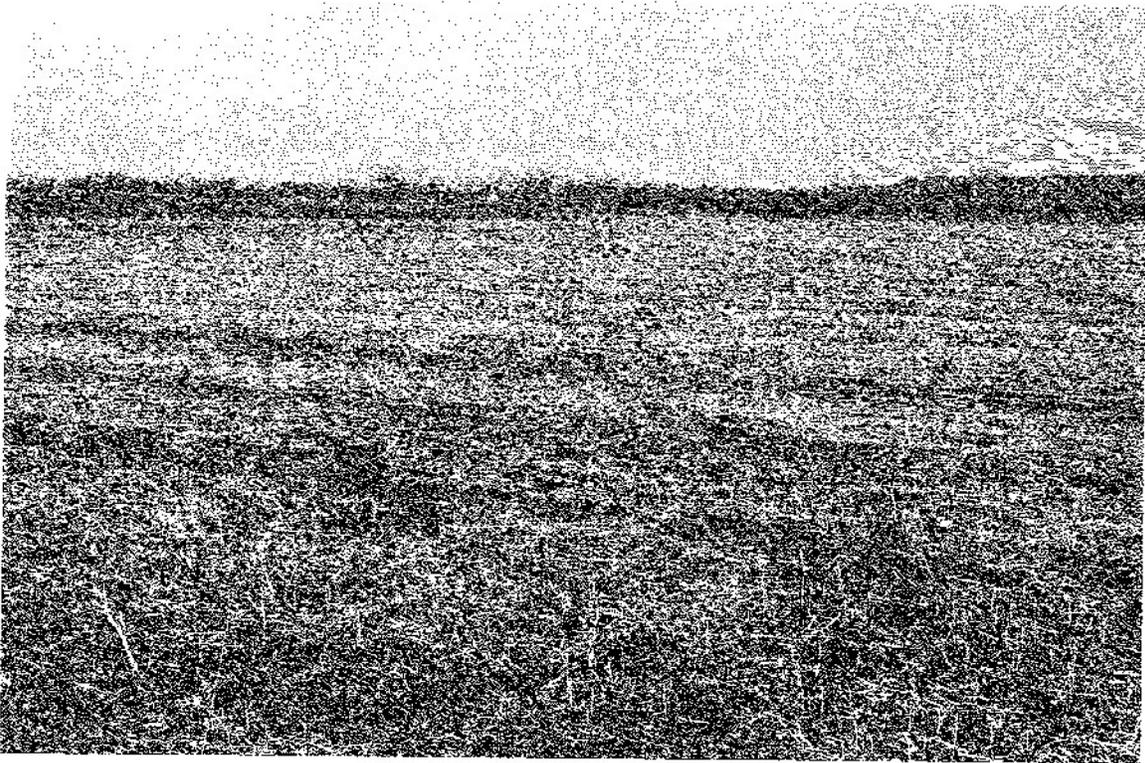
PHOTOGRAPH 4

4	Charles Hughes Property. This photograph was taken on the water-way that divides parcels 11 and 2. The view is to the north. The buildings in the background is the Lee Stadel residence that is adjacent to the Charles Hughes property.
5	Charles Hughes Property. This photograph was taken on the water-way that divides parcels 11 and 2. The view is to the south. The field of winter wheat in the background is the Belter property that is adjacent to the Charles Hughes property.
6	Charles Hughes Property. This photograph was taken on the water-way that divides parcels 11 and 2. The view is to the west. The buildings in the background is the David Hughes residence.
7	Elizabeth Belter Property. This photograph was taken from Wildcat Creek Road, looking southeast. The crop in the field is winter wheat. The building in the left background is the Manhattan Municipal Airport.
8	Elizabeth Belter Property. This photograph was taken from Wildcat Creek Road, looking northeast. The crop in the field is winter wheat. The buildings in the background are the Manhattan Municipal Airport facility.
